Thermography Inspection Report

Company	BSCS
Author	Brian Sweeney
Date	12th November 2008

Inspection 1 - Joe Blogs

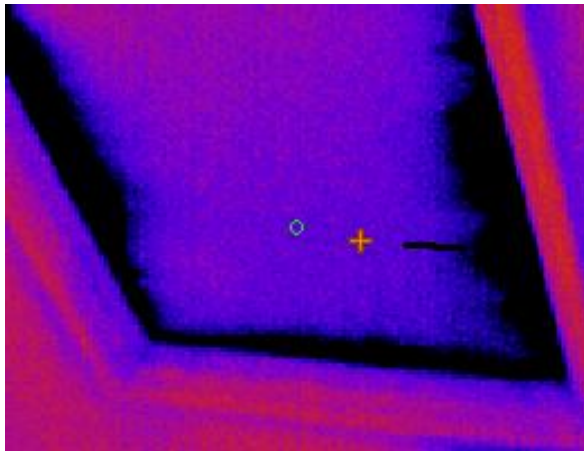
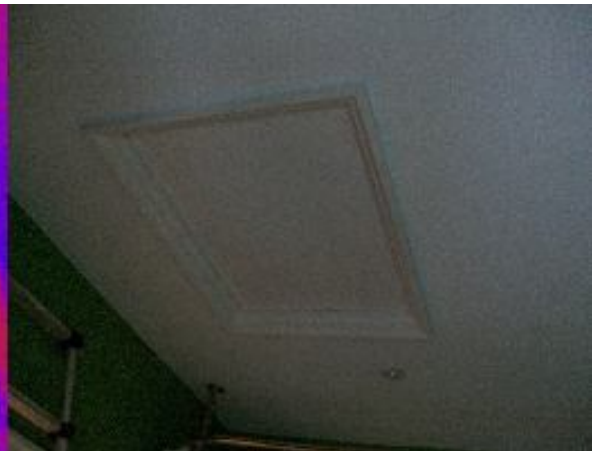
The thermal image clearly illustrates areas of air ingress through an unsealed and uninsulated attic door

Cursor 2	17.5 °C
Difference

5

The Attic trap door should be reinstalled with an insulated backing and a suitable draft proof seal

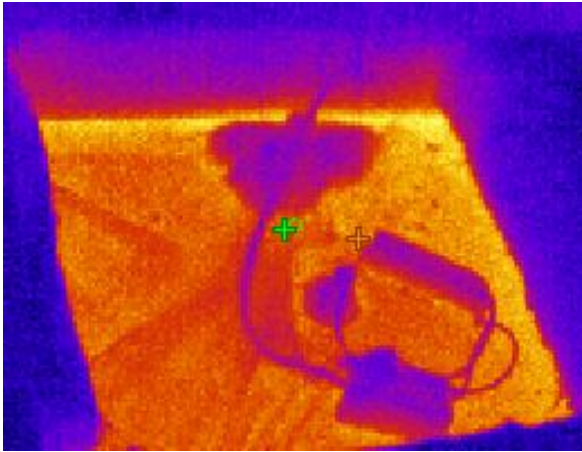
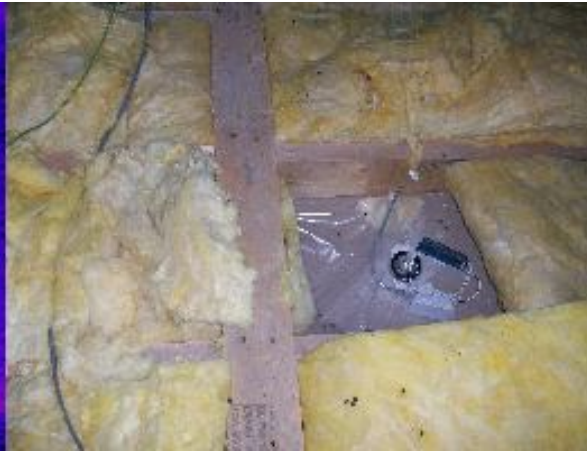
Inspection 2 - Joe Bloggs

Thermal image clearly shows the heat loss and temperature difference of an uninsulated section in the roof space .

Cursor 1	9.9 °C
Cursor 2	10.1 °C
Difference	-0.2 °C

5

The tradesmen involved removed insulation to make their job easier. Simply replace the insulation but ensure the light fitting is protected from over heating with a suitable shroud.

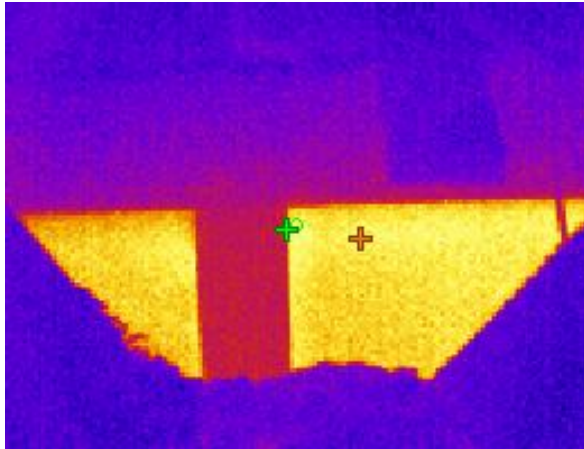
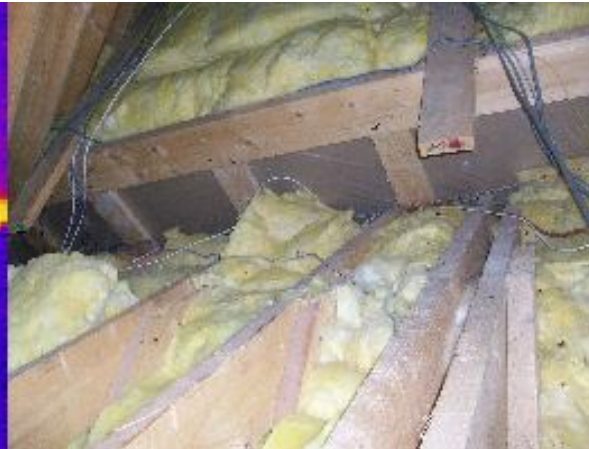
Inspection 3 - Joe bloggs

Thermal image clearly hows the heat loss and temperature difference in the attics uninsulated section.

Cursor 1	12.2 °C
Cursor 2	12.1 °C
Difference	0.1 °C

5

This entire high level section of wall requires insulation to be installed

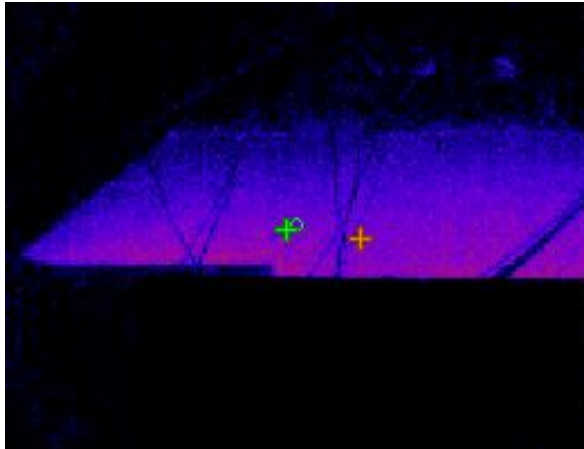
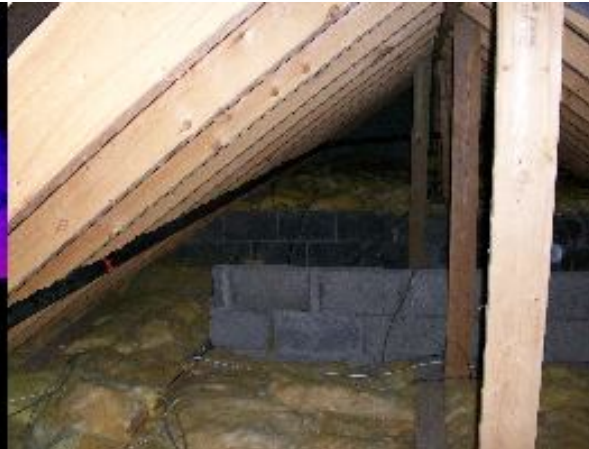
Inspection 4 - Joe Bloggs

The thermal image shows heat loss through poorly installed sections of insulation.

Cursor 1	7.1 °C
Cursor 2	7.0 °C
Difference	0.1 °C

4

The exposed concrete wall is exacerbating heat loss through conduction. This wall should be correctly insulated.
